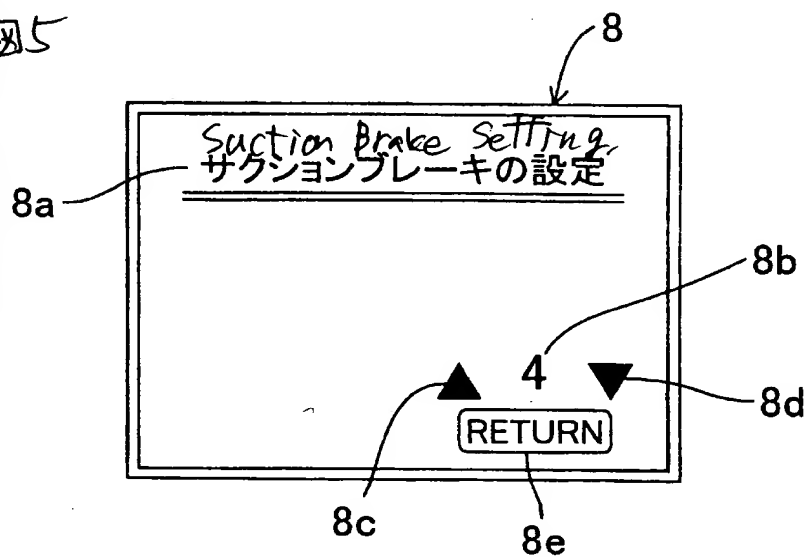
Fig-5

印字搬送フロー

Paper feed

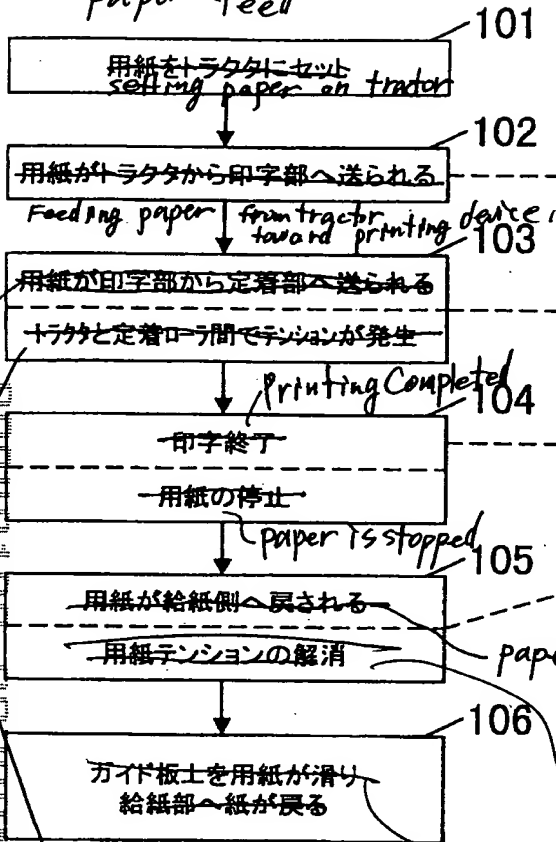
ブレーキ動作フロー

Braking

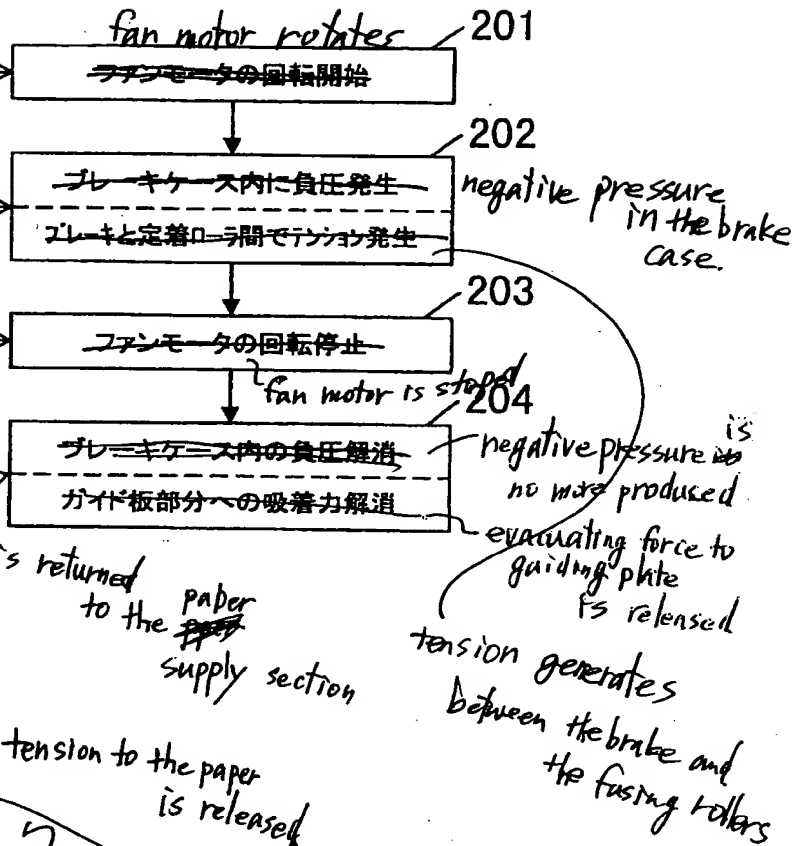
Fig. 7.

Feed paper from tractor toward the fusing section

Tension ~~generates~~ generates between the tractor and the fusing rollers

paper is returned to the paper supply section while sliding on the guiding surface.

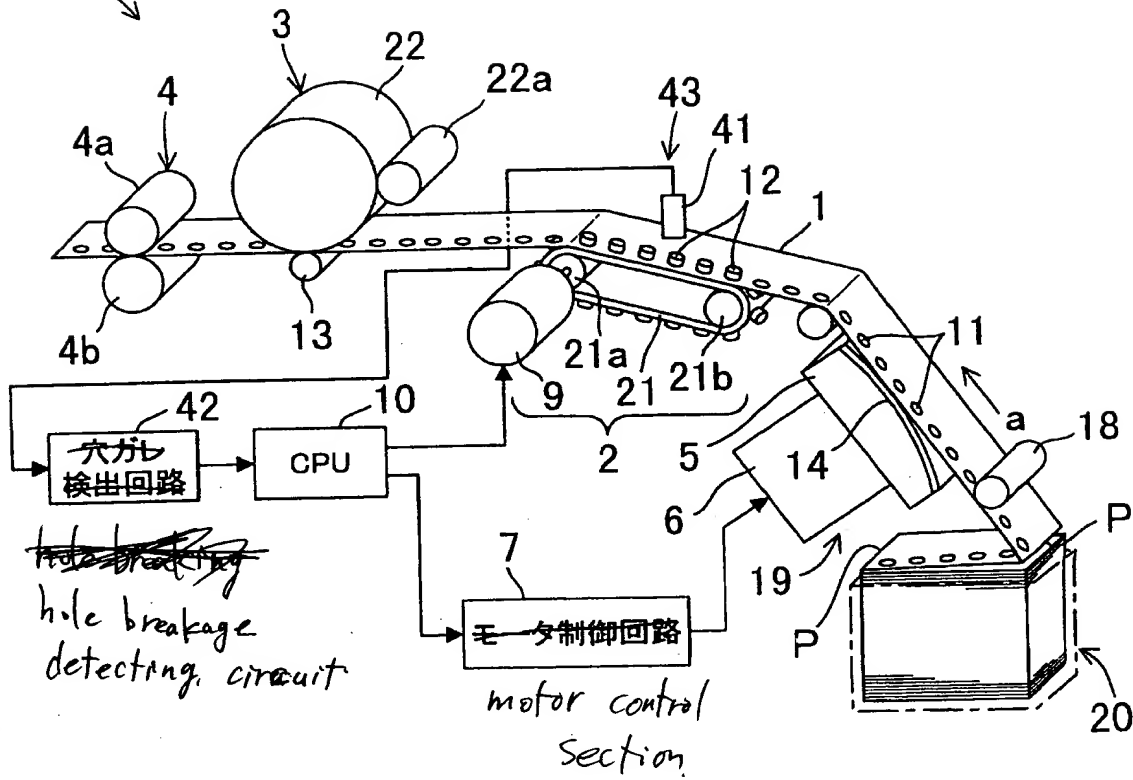
FIG. 12

(a) No hole breakage
穴破れなし

(b) Hole breakage at upstream side edge
上流側縁に穴破れ

(c) Hole breakage at downstream side edge
下流側縁に穴破れ

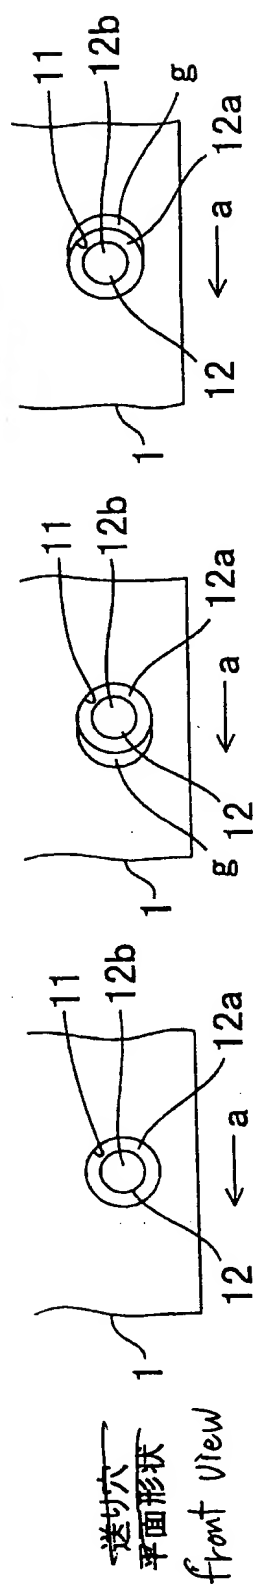
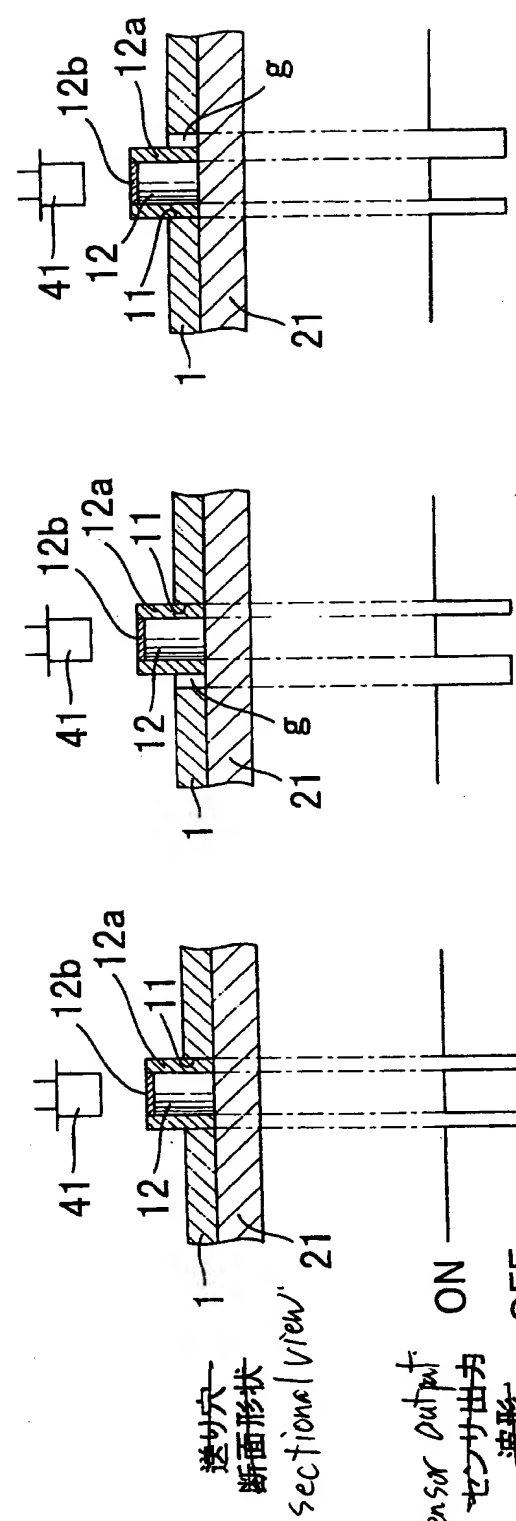
Fig. 12

sensor output
センサー出力
波形

ON
OFF

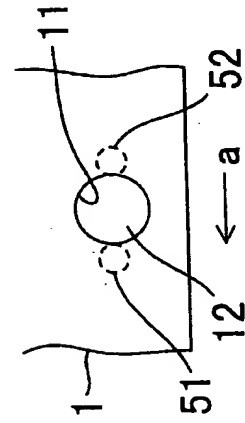
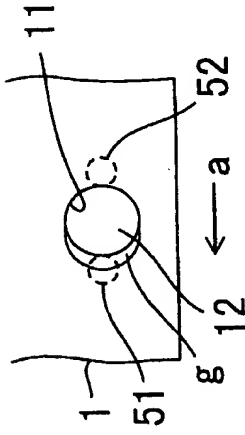
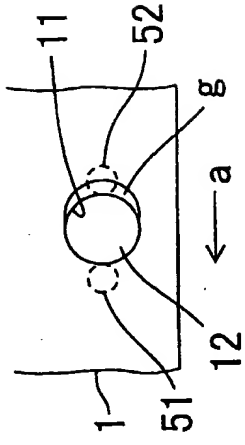
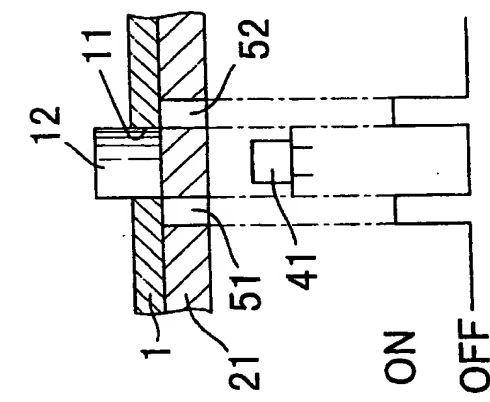
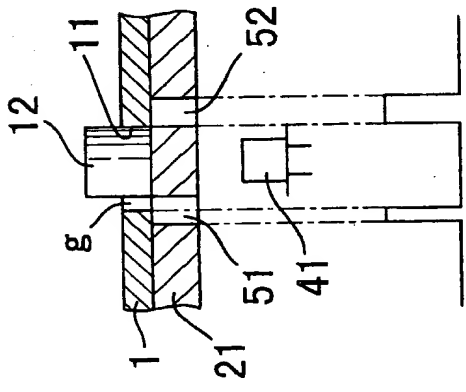
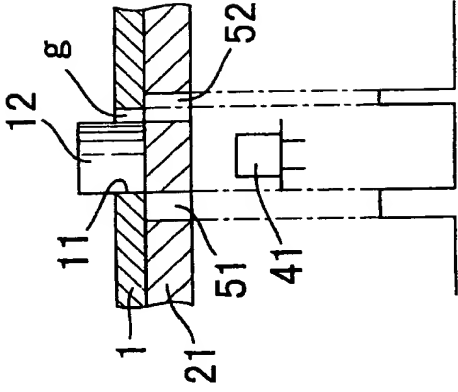
Fig. 13

(a) No Hole Breakage
穴が壊れない

送り穴
平面形状
front view

(b) Hole Breakage
穴が壊れる
主流側縁に穴が壊れる

Hole Breakage
(c) at downstream edge
下流側縁に穴が壊れる

送り穴
断面形状
sectional view

sensor output.
センサー出力
波形
ON
OFF
